## BOOTT COTTON MILLS (The Boott Mills) Lowell, Massachusetts

# Tech Notes

NUMBER 18

### Aluminum Replacement Windows With True Divided Lights, Interior Piggyback Storm Panels, and Exposed Historic Wooden Frames

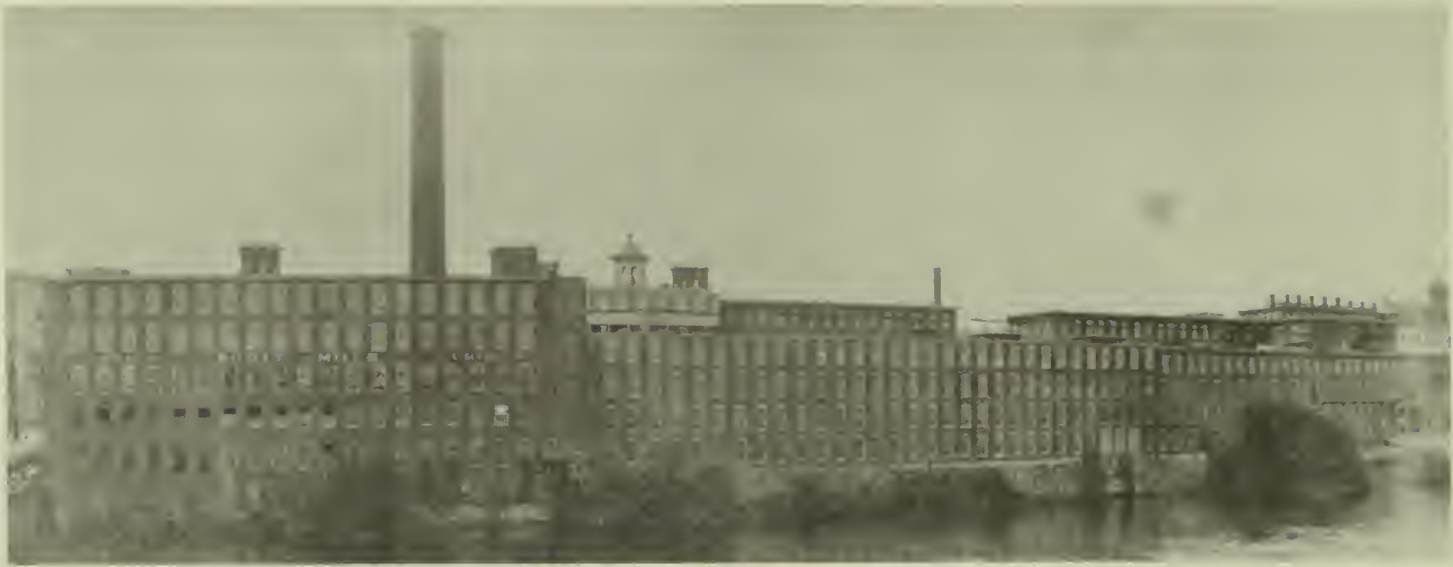
Figure 1. The windows are the dominant element of detail and decoration in the Boott Cotton Mills. Photo: Courtesy of the Center for Lowell History

minum window technology with an older double-glazing technique. The new windows that were developed virtually duplicated many of the important historic attributes of the original wooden windows on the large mill facades (see figure 1).
